VTrans PDD-LTF FY17 Vermont Better Roads Grant Application

Town and Road Name: Thayer Brook Rd, Braintree

Project Name: Thayer Brook culverts + ditching

Site Description

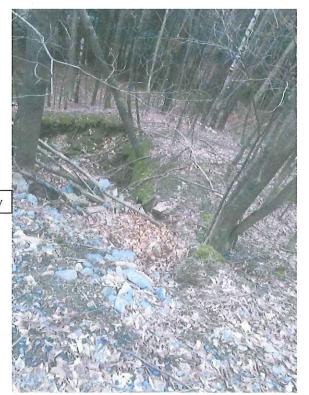
Culvert 12: Outlet Gully

Culvert #12 is 15" x 25' steel culvert in poor condition. Recommneded upgrade to 18" by 40' steel and improve ditching to inlet. The outlet has existing gully erosion, and 15 yards of rip rap should be installed from the outlet to reduce erosion.

Culvert #12 - existing 15" x 25' steel - poor condition, too short. Recommend upgrade to 18" x 40' steel and improve ditching to inlet. The outlet has existing gully erosion, recommend around 15yds of riprap from outlet to reduce erosion.

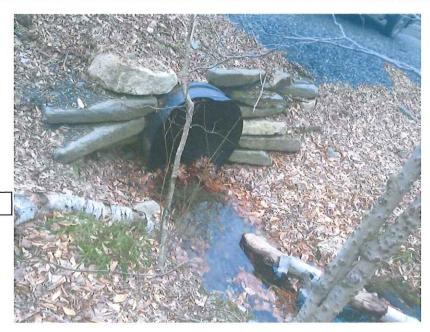
Culvert 10: Inlet

Culvert #10 is a 48" x 40' plastic culvert in good condition, but can be replaced with 48" x 40' and reset lower in the ground for improved drainage of an intermittent stream. Riprap should be installed below the outlet to reduce perched culvert erosion impacts.

Culvert #10 - existing 48" x 40' plastic - good condition but can be replaced with 48" x 40' and reset lower in ground for improved drainage as there is an intermittent stream. Add riprap below outlet to reduce perched erosion impacts.
